BRADYS LAKE DAM

PHASE I INSPECTION REPORT NATIONAL DAM INSPECTION PROGRAM

BRADYS LAKE DAM, MONROE COUNTY
PENNSYLVANIA

NDS I.D. NO. PA 00782
DER I.D. NO. 45-8

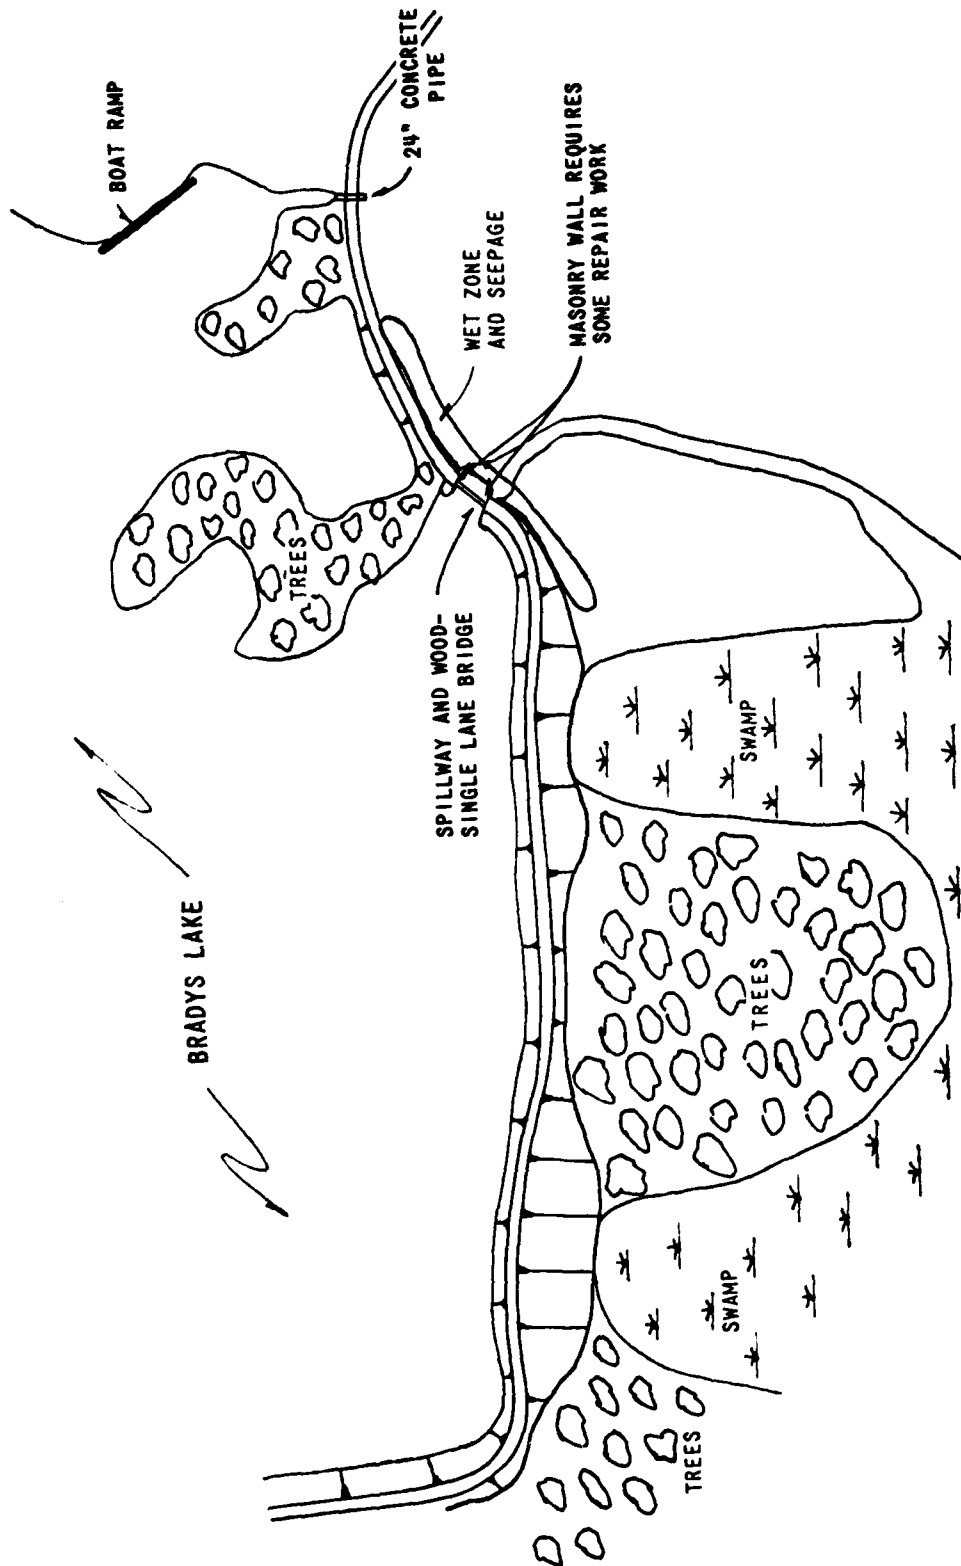
SHEET 5A OF 11

Seepage was noted as shown on sheet 5a. All of this seepage was observed at the left end of the dam at the downstream toe between the 24-inch pipe and the spillway. This same seepage was noted in previous inspection reports, which date as far back as June 1934. Because of the backwater/swamp from the beaver dam, possible seepage under the right end of the dam may not be visible.

The wet areas, noted on sheet 5a, Appendix B, downstream of the embankment to the left of the spillway have been a source of seepage for more than 45 years. Based on available documentation, there has been no significant change in the rate of seepage for at least that period of time. Thus, it is judged that this seepage is in a reasonably stable condition, but does not discount the fact that it should be monitored.

Yes. See Sheet 5a, all of the seepage was observed at the left end of the dam at the downstream toe between the 21 inch pipe and the spillway.

2. Seepage at the downstream toe should be periodically monitored and checked, at least visually, for increases in rates or changes in turbidity.
3. The spillway should be rehabilitated to a good condition.
